Burns Home Services

SUMMARY REPORT

Client: John Smith
Inspection Address: 1234 Nowhere Rd., Phoenix, AZ 85555
Inspection Date: 7/18/2006 Start: 9:00 am End: 12:30 pm
Inspected by: Garry Hukill

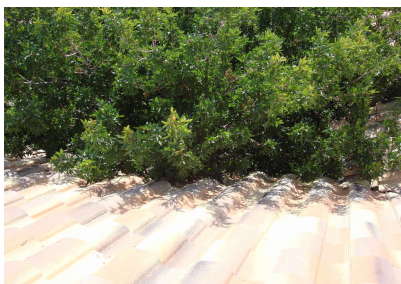
- 1.1 - There are tree limbs overgrowing the residence that should be trimmed or monitored, to insure that they do not impact or damage the roof or its components.

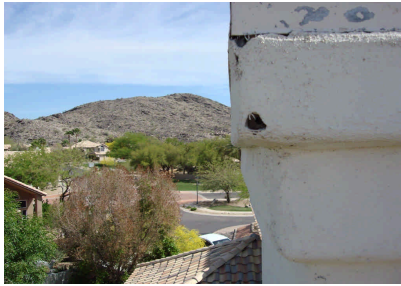
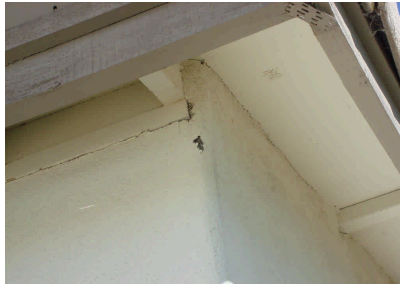
- 1.2 - 1. Hole noted in stucco at southwest corner of fireplace crown.
2. Hole noted in stucco at southeast corner of house at eave area.

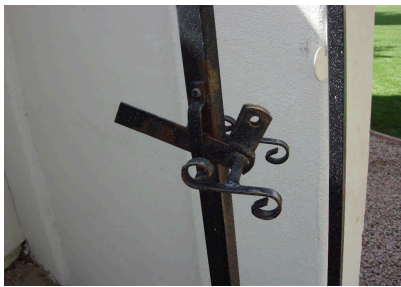
- 1.3 - The rod iron gate at west side of property needs to have handle reattached to gate. Recommend repair.

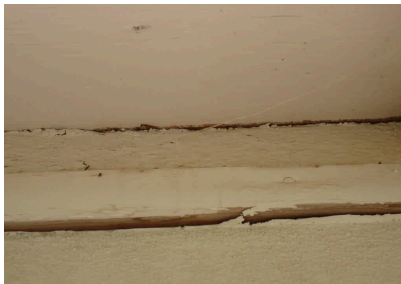
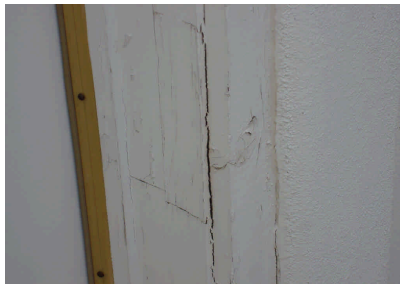
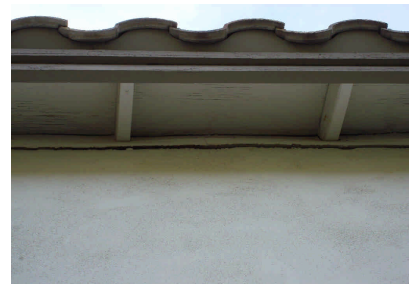
- 1.4 - 1. Area of moisture damage noted at back patio cover. Recommend repair
2. Area of open seams and moisture damage noted at back door of garage trim. Recommend repair.
3. Area of separation noted at eave line of west wall. Recommend repair.

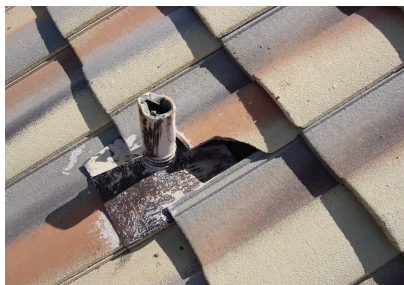
- 3.1 - There are a number of cracked or broken tiles that should be serviced, recommend consulting a licensed roofing expert for further analysis and repair.

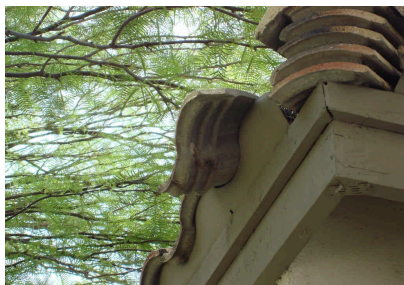
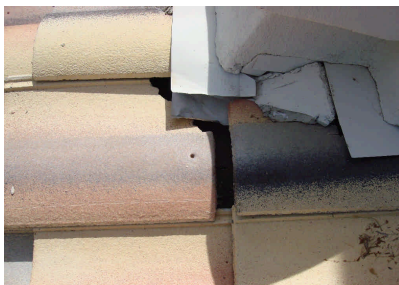
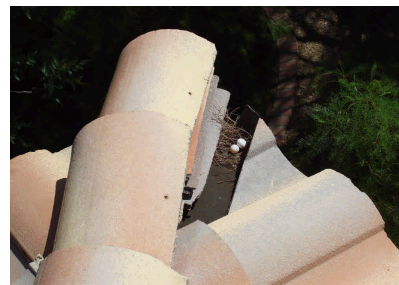
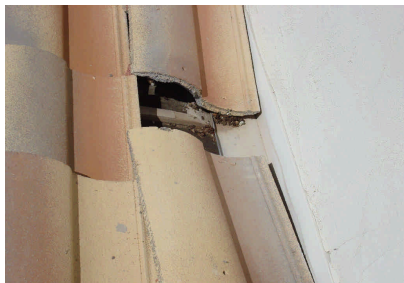
3.2 - There are a number of missing or displaced tiles that have exposed the waterproof membrane, which should be serviced or the roof could leak.

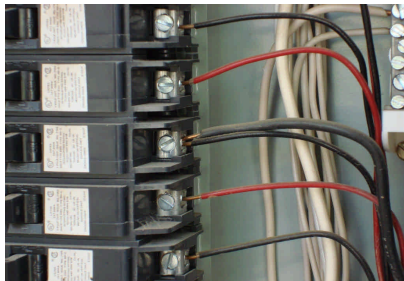
6.1 - A fifteen-amp breaker is serving two circuits. This condition should be evaluated by an electrician.

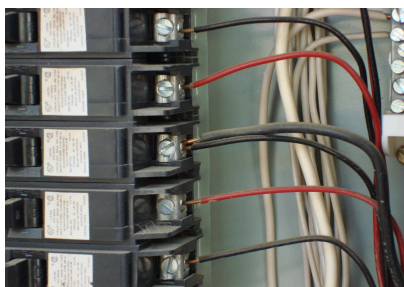
6.2 - A fifteen-amp breaker is serving two circuits, which could overload the circuits. This condition should be evaluated by an electrician.
