Burns Home Services

CONFIDENTIAL INSPECTION REPORT

1234 Nowhere Rd., Phoenix, AZ 85555

7/18/2006 9:00 am to 12:30 pm

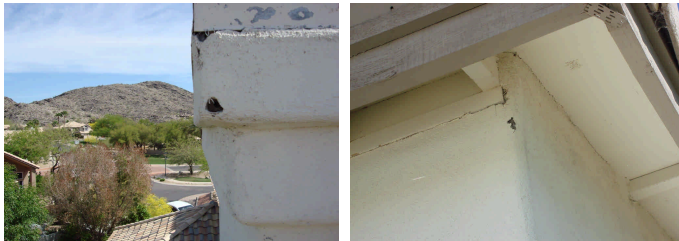
1. Hole noted in stucco at southwest corner of fireplace crown.
2. Hole noted in stucco at southeast corner of house at eave area.
